INDOOR AIR QUALITY ASSESSMENT

**Swampscott High School
1 Forest Avenue
Swampscott, Massachusetts**

Prepared by:
Massachusetts Department of Public Health
Bureau of Environmental Health Assessment
March, 2001

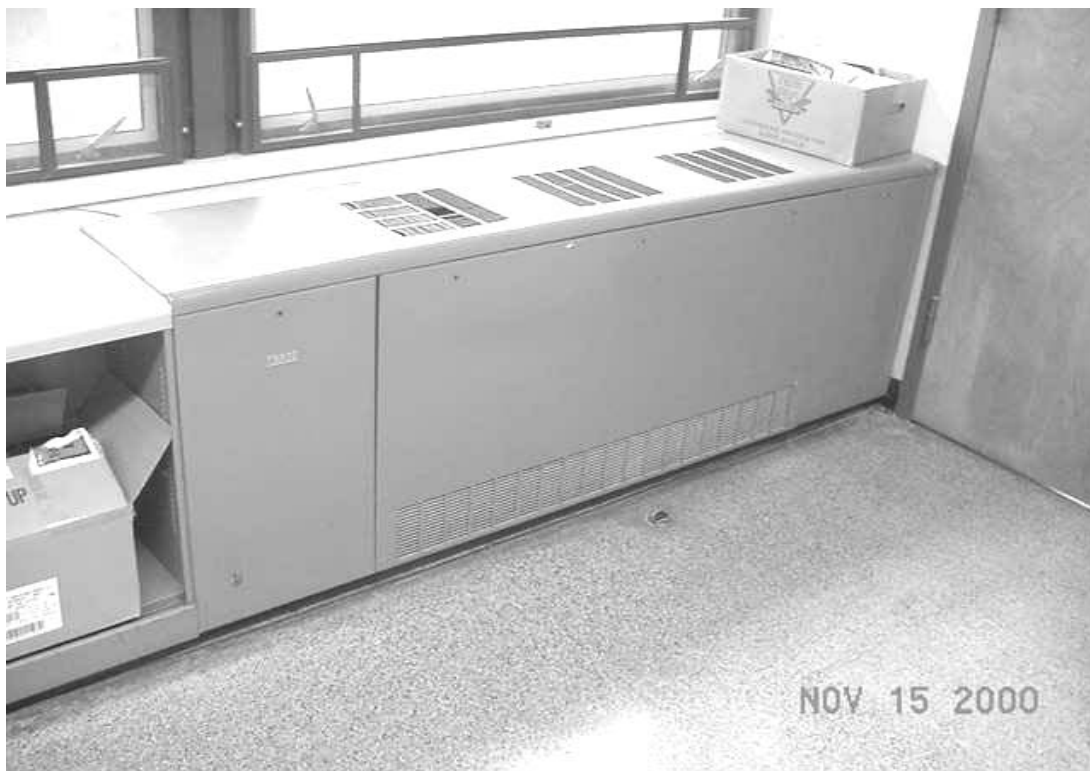
Picture 1

Classroom Univent

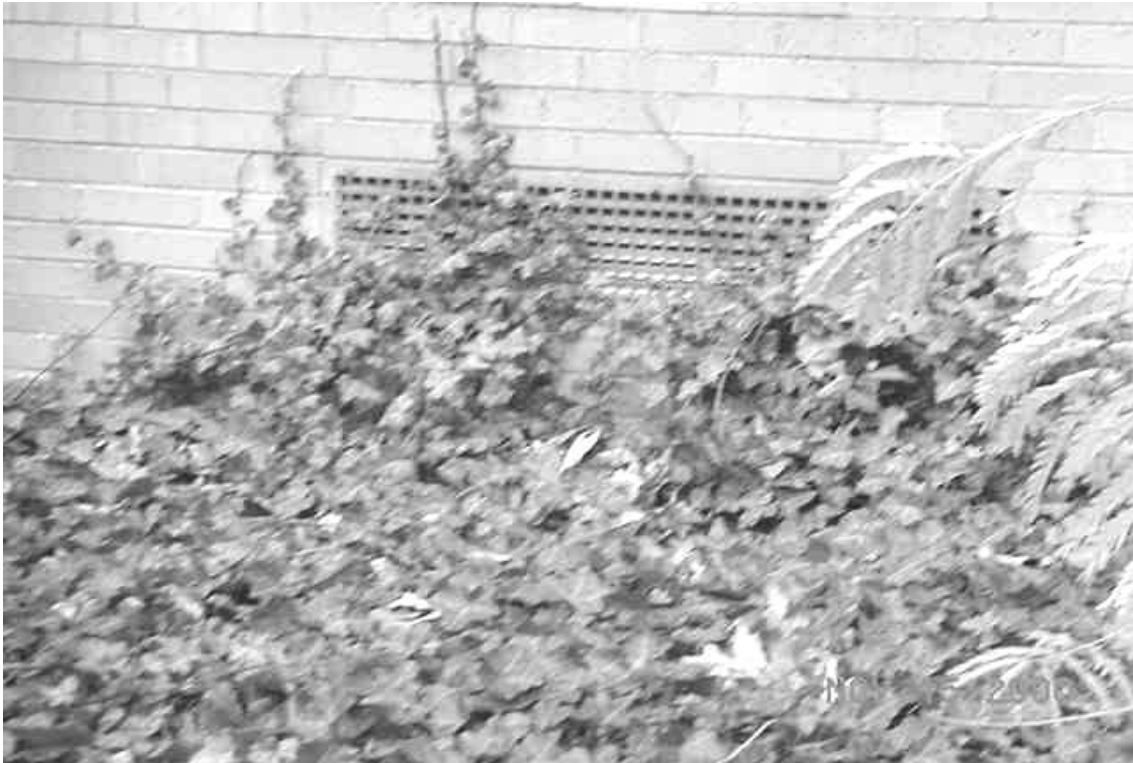
Picture 2

Univent Fresh Air Intake Obstructed by Plant Growth

3. Consider having the ventilation system balanced by a ventilation engineer.
4. Remove all obstructions from supply and exhaust vents to facilitate airflow. Clear shrubbery from univent intakes on exterior of the school.

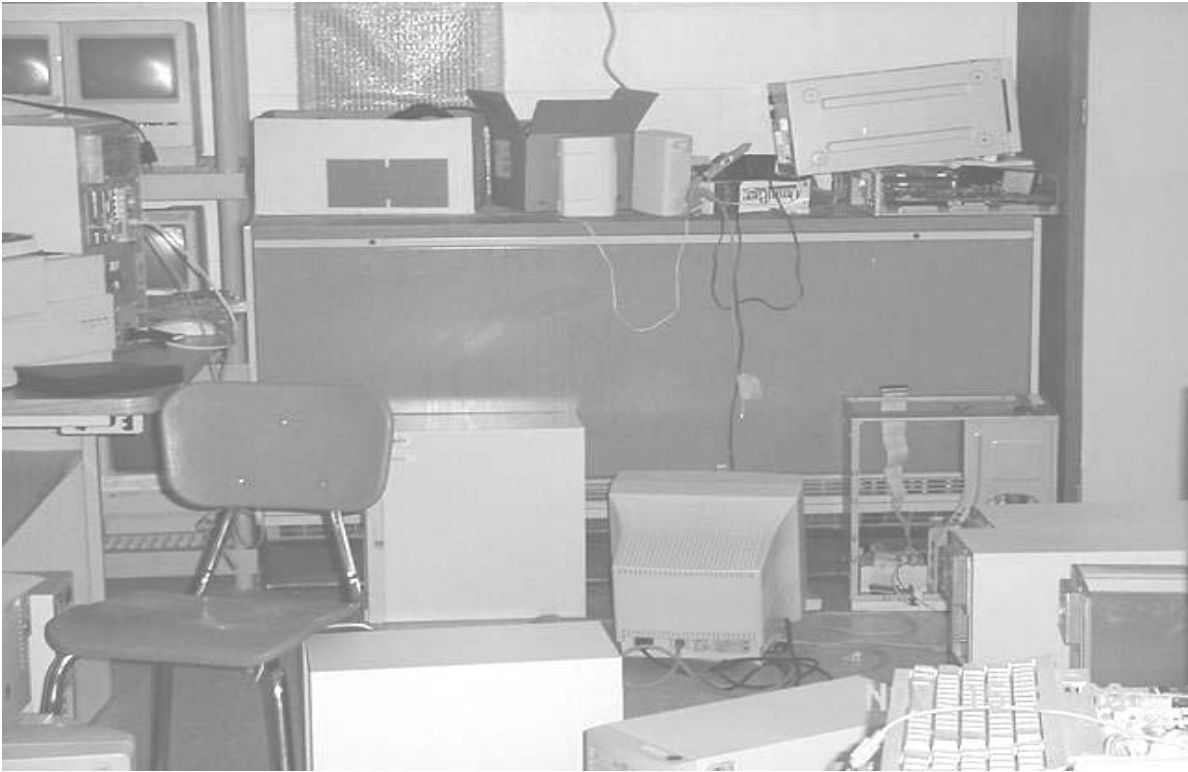
Picture 3

Univent Obstructed by Various Items

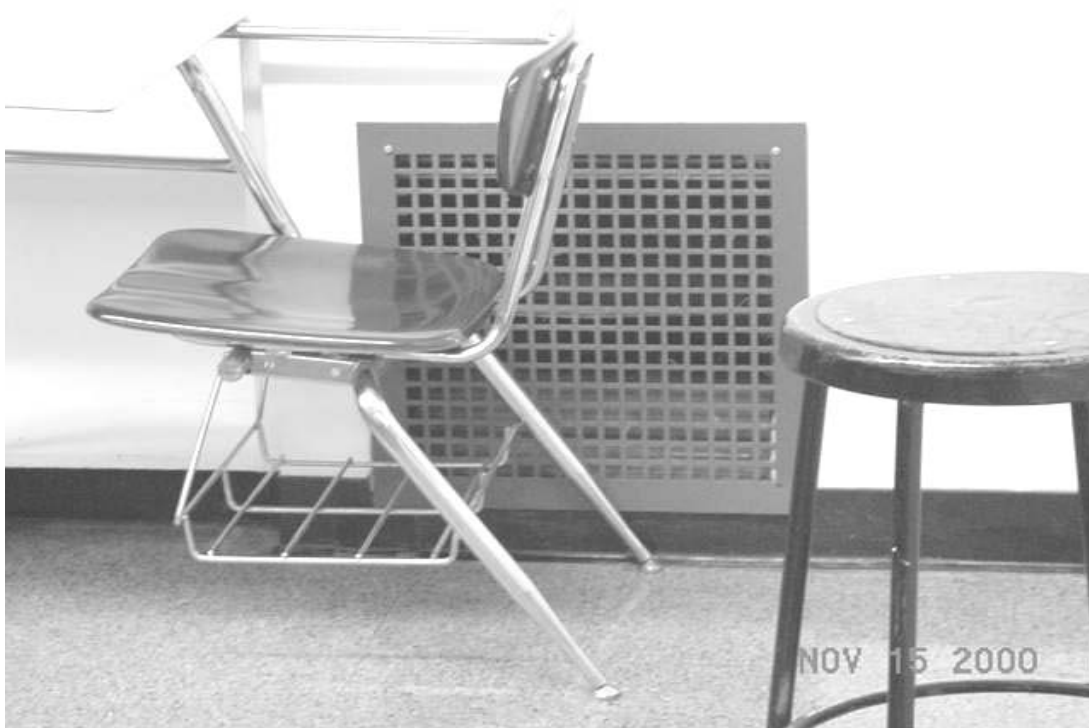
Picture 4

The mechanical exhaust ventilation system in each classroom consists of ducted, grated wall/ceiling vents; many of which were obstructed by furniture, storage carts, shelves

and other items (see Picture 4). Exhaust vents were functioning in most classrooms. Exhaust ventilation for science classrooms is provided by ceiling-mounted exhaust vents located in a chemical storeroom between science classrooms. Passive grills are mounted on the storeroom doors to draw classroom air into the storerooms and out of the building through the exhaust vents (see Pictures 5 & 6). The science classroom ventilation systems were also operating during the assessment, however classroom occupants complained of lingering odors after conducting science experiments. Carbon dioxide readings in the science area were above 800 ppm, which as discussed previously can indicate poor air circulation.

Classroom Exhaust Vent

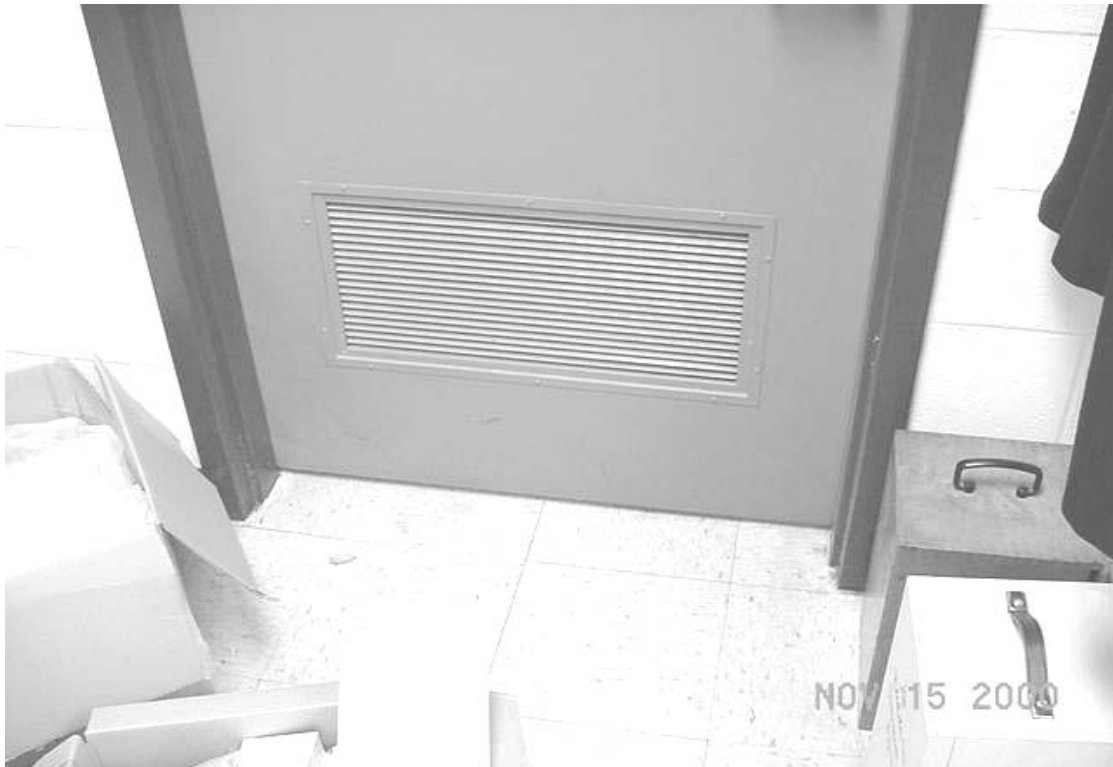
Picture 5

Passive Vent on Chemical Storeroom Door Providing Exhaust Ventilation for Science Classroom

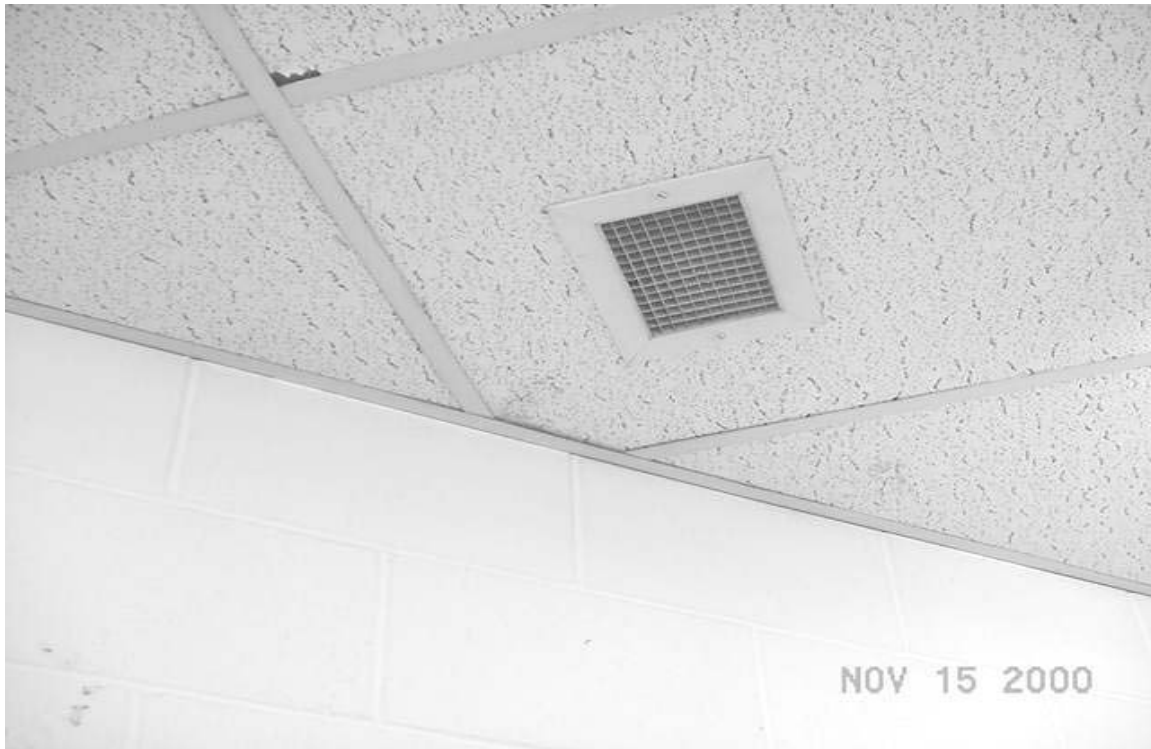
Picture 6

Ceiling Mounted Exhaust Vent for Science Classroom Located in Chemical Storeroom

19. Replace damaged flexible ductwork for local exhaust in the wood shop.
20. Determine whether the ceiling vent in the chemical storeroom is functioning. Repair if not functioning. If the vent is part of the general exhaust ventilation system, seal this vent to prevent chemical odors from penetrating into occupied areas.

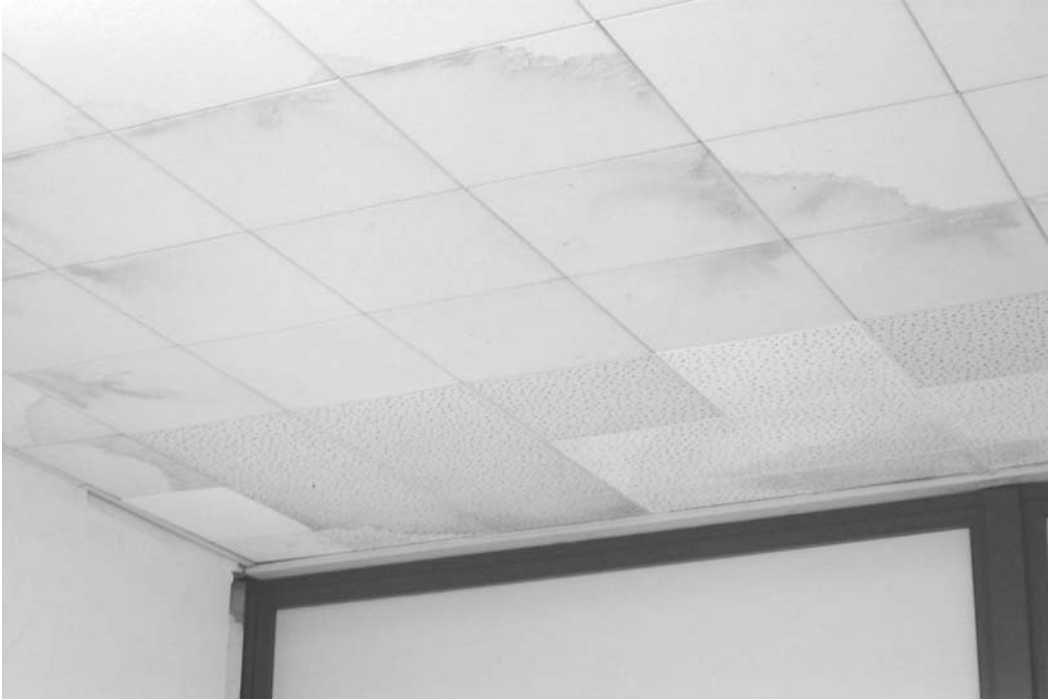
Picture 7

A number of rooms had water-stained ceilings and ceiling tiles, which are evidence of roof and/or plumbing leaks (see Picture 7). Water-damaged ceiling tiles can provide a source of mold and mildew growth and should be replaced after a leak is discovered. Plants were noted in several classrooms. Plants can be a source of pollen and mold, which can be a respiratory irritant to some individuals. Plants should be properly maintained and be equipped with drip pans. Plants should also be located away from air diffusers to prevent aerosolization of dirt, pollen or mold. Along the outside perimeter of the school several fresh air intakes are partially obstructed with shrubbery (see Picture 2). Shrubby can be a source of moisture and/or pollen, which can be pulled into air intakes (called entrainment) and subsequently distributed into the classroom.

Water Damaged Ceiling Tiles

8. Repair any existing water leaks and replace any remaining water-stained ceiling tiles. Examine the areas above these tiles for mold growth. Disinfect areas of water leaks with an appropriate antimicrobial as needed.

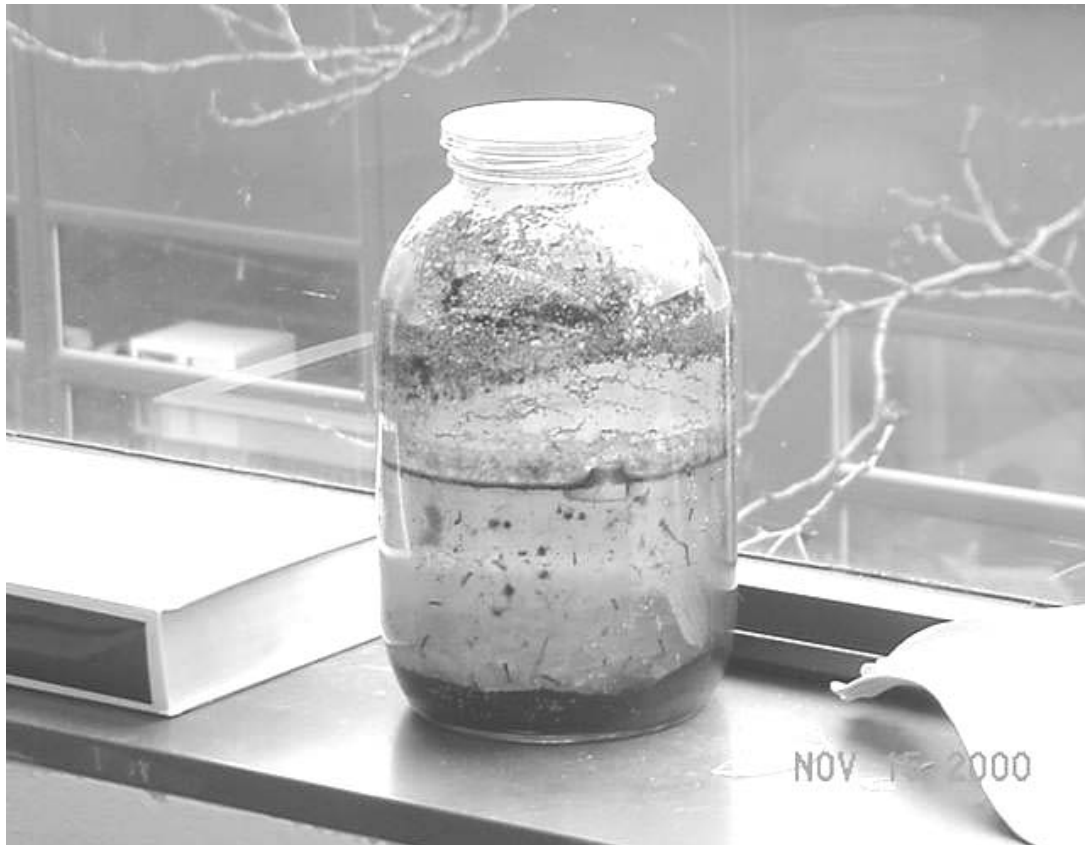
Picture 8

Room 238 contained a jar of standing water with algae growth, located near the univent (see Picture 8). Standing water can lead to algae/mold/bacterial growth. These growths can be a source of foul odors and can be irritating to some individuals.

Algae Growth in Standing Water near Univent in Classroom 238

11. Remove jar of standing water from univent area in classroom 238.
12. Clean chalkboards and trays regularly to prevent the build-up of excessive chalk dust.

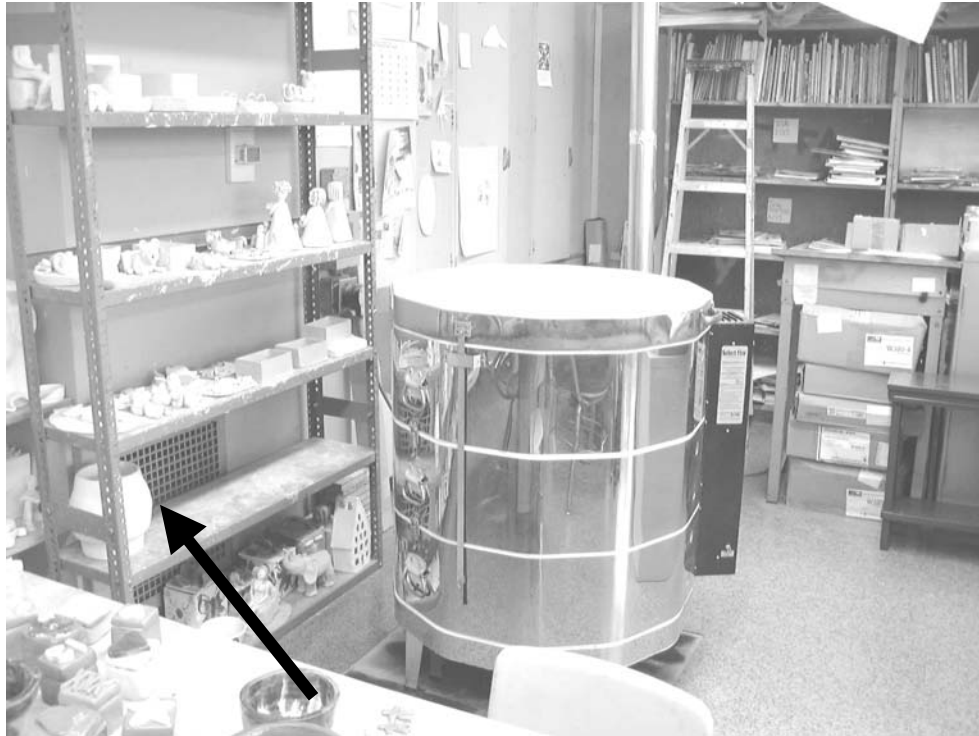
Picture 9

A kiln was observed in the art room 102 (see Picture 9). The kiln was equipped with local exhaust ventilation and was operating during the assessment. Kiln exhaust may contain hazardous and irritating materials including sulfur dioxide and carbon monoxide. A working exhaust vent to the main school ventilation system was found in the art room close to the kiln's location. This vent can possibly compete with the local exhaust provided to entrain kiln odors/exhaust and introduce these pollutants to other sections of the school.

General Exhaust Vent

Kiln in Art Room 102

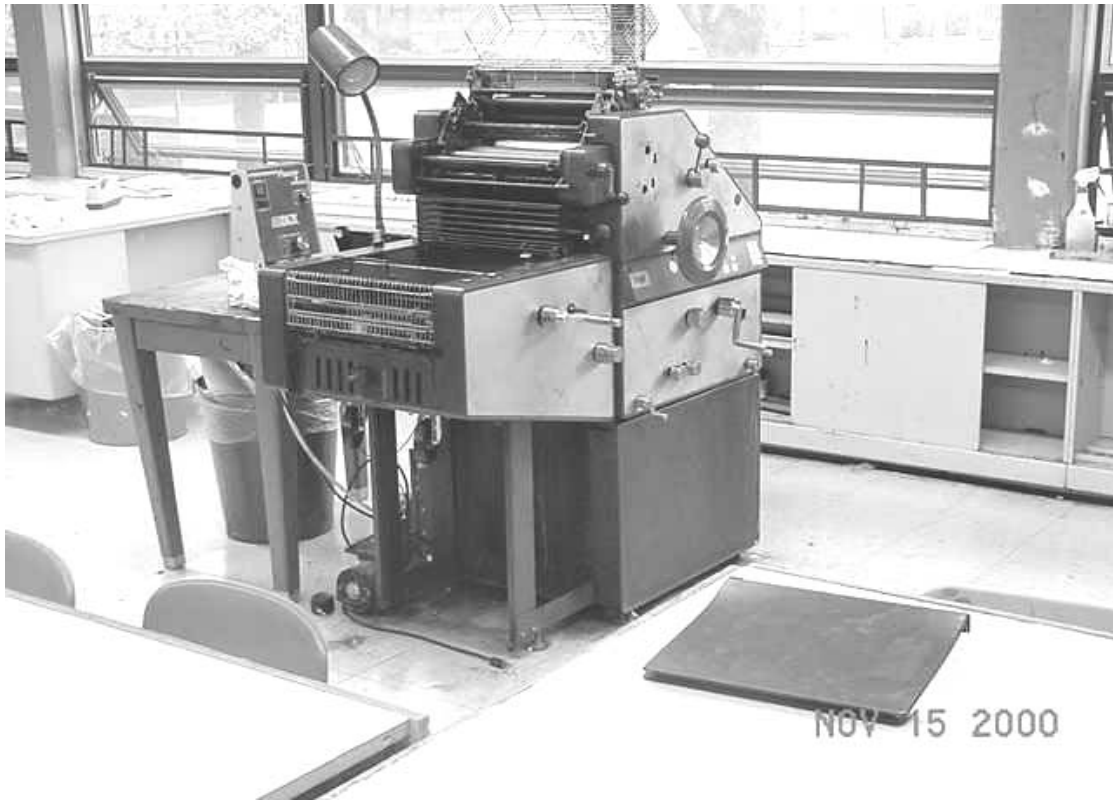
Picture 10

The print shop is located in a classroom with a univent and general exhaust vent. No dedicated local exhaust ventilation system exists for printers to remove ink odors (see Picture 10). Inks and other printing materials may contain petroleum hydrocarbons and/or VOCs, which evaporate after application. Without dedicated exhaust ventilation, VOCs can migrate from the print shop to adjacent areas. Material safety data sheets (MSDS') for the hazardous materials used in printing should be obtained and consulted in order to gauge the appropriate design of local exhaust ventilation necessary for printing presses. No print shop activities were being conducted at the time of the BEHA assessment.

Printing Press in Print Shop/Classroom

2. Relocate or consider installing local exhaust ventilation to draw chemical odors away from printing press operators. Consider consulting a certified industrial hygienist for appropriate ventilation in this area.
3. Consider relocating the kiln to a separate room and/or closer to the outside wall to aid mechanical exhaust and to avoid potential exposure to kiln emissions.

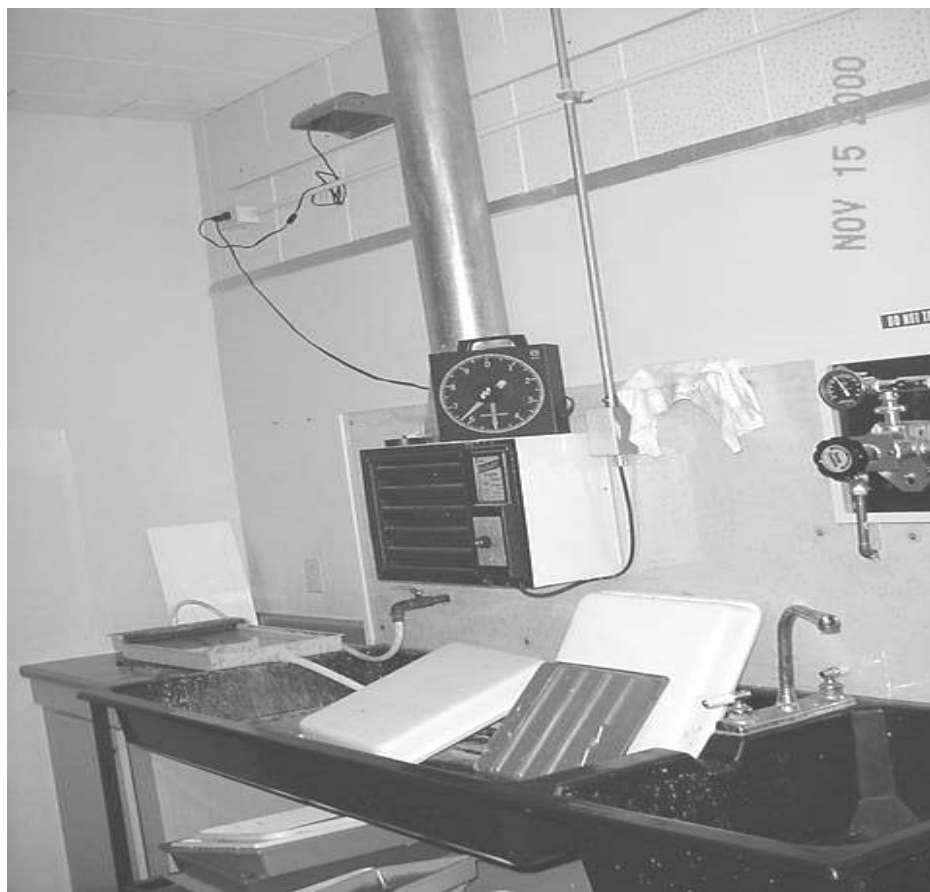
Picture 11

The darkroom, adjacent to the print shop, has a local exhaust hood to draw odors away from users (see Picture 11). A switch on the wall activates the exhaust hood. The switch was “off” during the assessment, which means the exhaust system was deactivated. No photo developing activities were being conducted during the assessment. The hood was activated by BEHA staff. Darkrooms use a number of developing chemicals containing VOCs, which can create odors, and can be irritating to the eyes, nose and throat.

Local Exhaust Vent Located in Dark Room

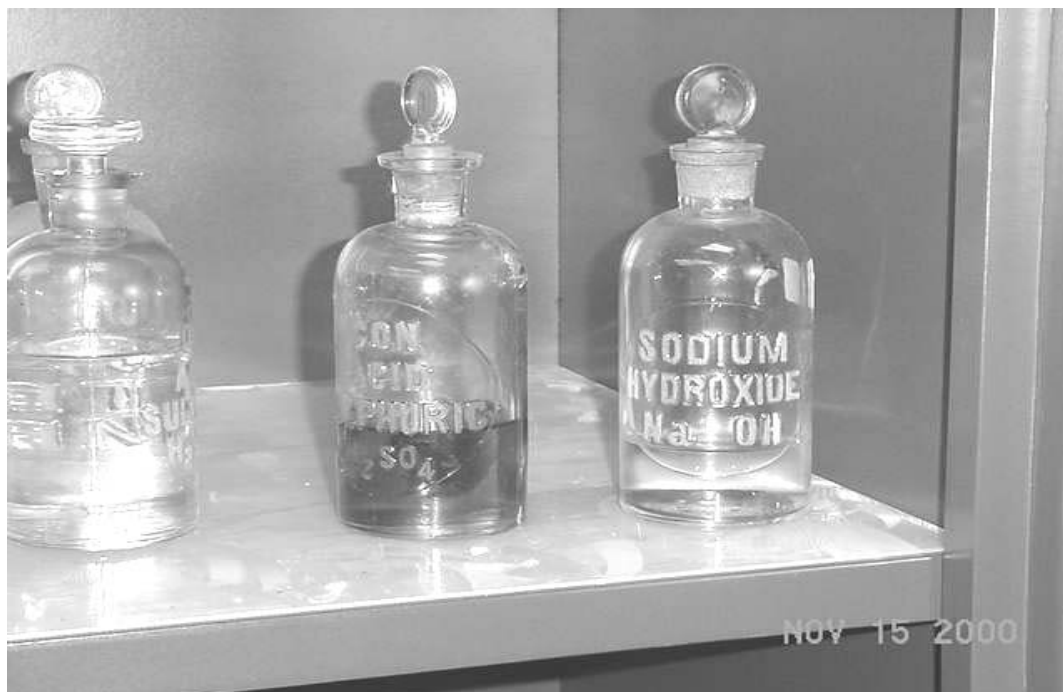
Picture 12

- Bases being stored in an acid storage cabinet along with acids (see Picture 12). Bases and acids should not be stored together.
- A number of materials appear to be of extreme age. A can of insecticide dated 1968 was stored in the flammables locker (see Picture 13).
- The finishing room of the woodshop contained a flammables locker that had unlabeled containers. As discussed previously, some containers were not sealed properly (see Picture 14) and were off gassing VOCs.

Acids and Bases Stored on Together

16. Store flammable materials in flameproof cabinets in a manner consistent with state and local fire codes.
17. Consider obtaining an acid resistant storage cabinet for the chemistry storeroom.

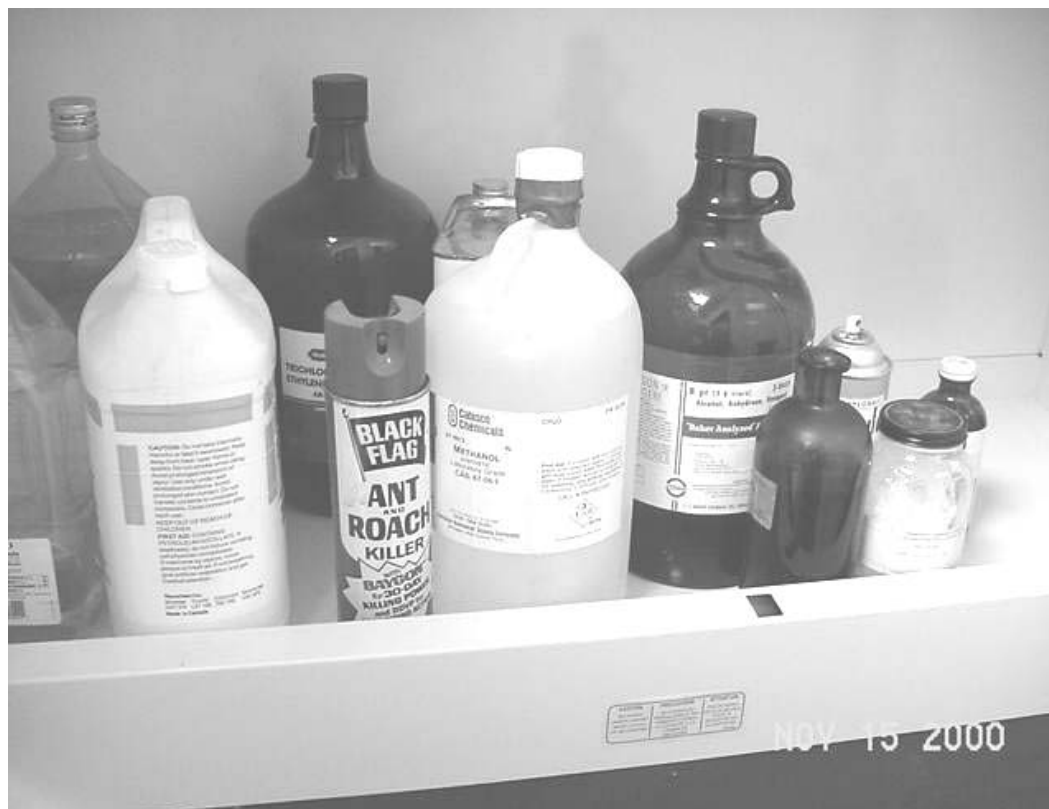
Picture 13

Chemical Storage Note Pesticide Spray Can

14. Store cleaning products and chemicals properly and keep out of reach of students.
15. Have a chemical inventory done in all storage areas and classrooms. Discard hazardous materials or empty containers of hazardous materials in a manner consistent with environmental statutes and regulations. Follow proper procedures for storing and securing hazardous materials. Obtain Material Safety Data Sheets (MSDS') for chemicals from manufacturers or suppliers.

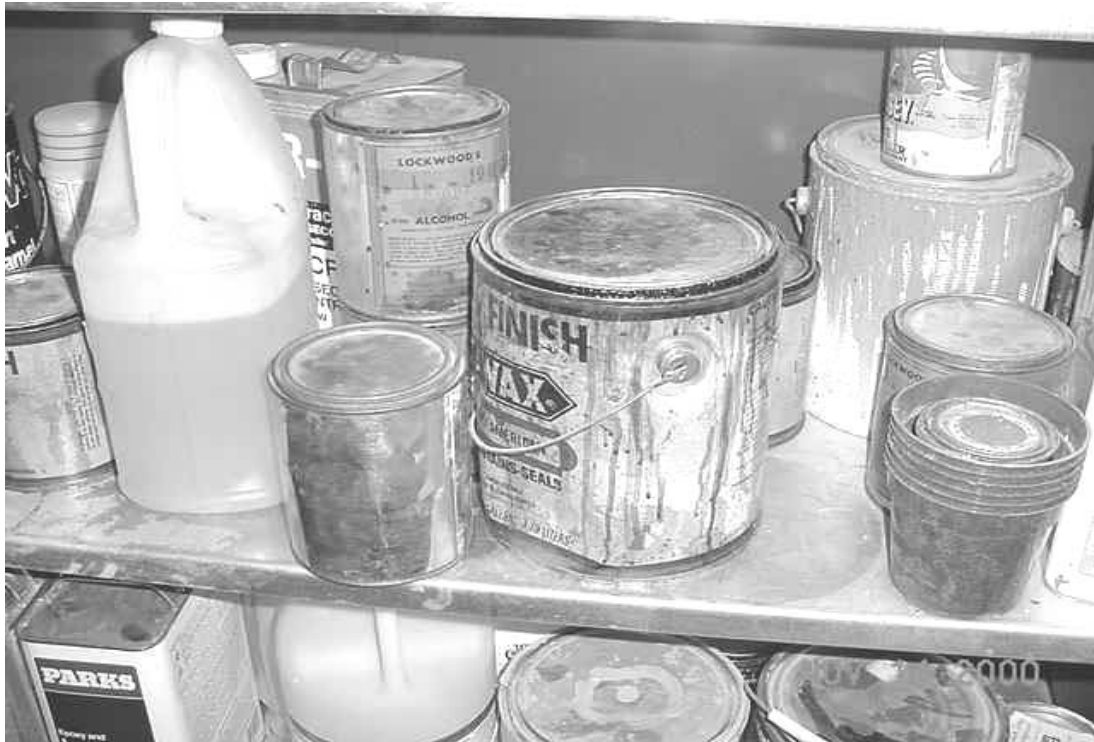
Picture 14

**Contents of Woodshop Storage Cabinet
Note Unlabeled and Improperly Sealed Containers**

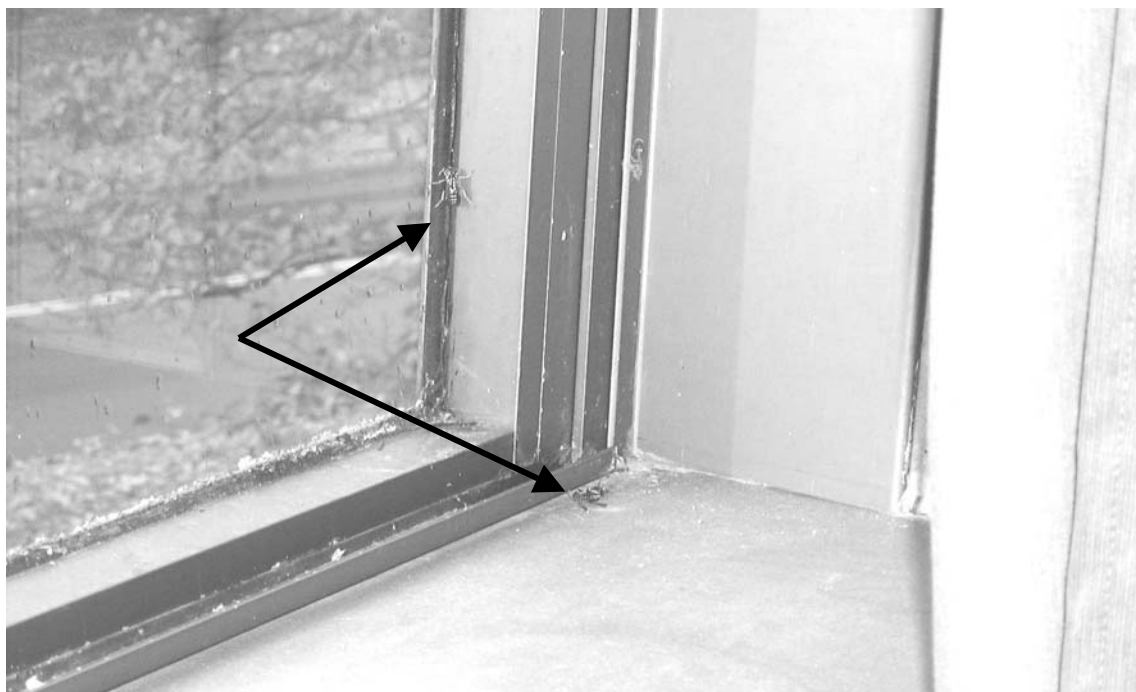
Picture 15

Yellowjackets were observed on/around a window of the choral room (see Picture 15). Yellowjackets are stinging insects and can cause allergic reactions in certain individuals. Other insect bodies were also seen on the windowsill. Insect parts can become dried out and aerosolized and may also serve as a source of allergenic material for sensitive

Yellow Jackets on Window in Choral Room

individuals. Under current Massachusetts law that will go into effect November 1, 2001, the principles of integrated pest management (IPM) must be used to remove pests in state buildings (Mass Act, 2000). A copy of the IPM guide is attached as Appendix A.

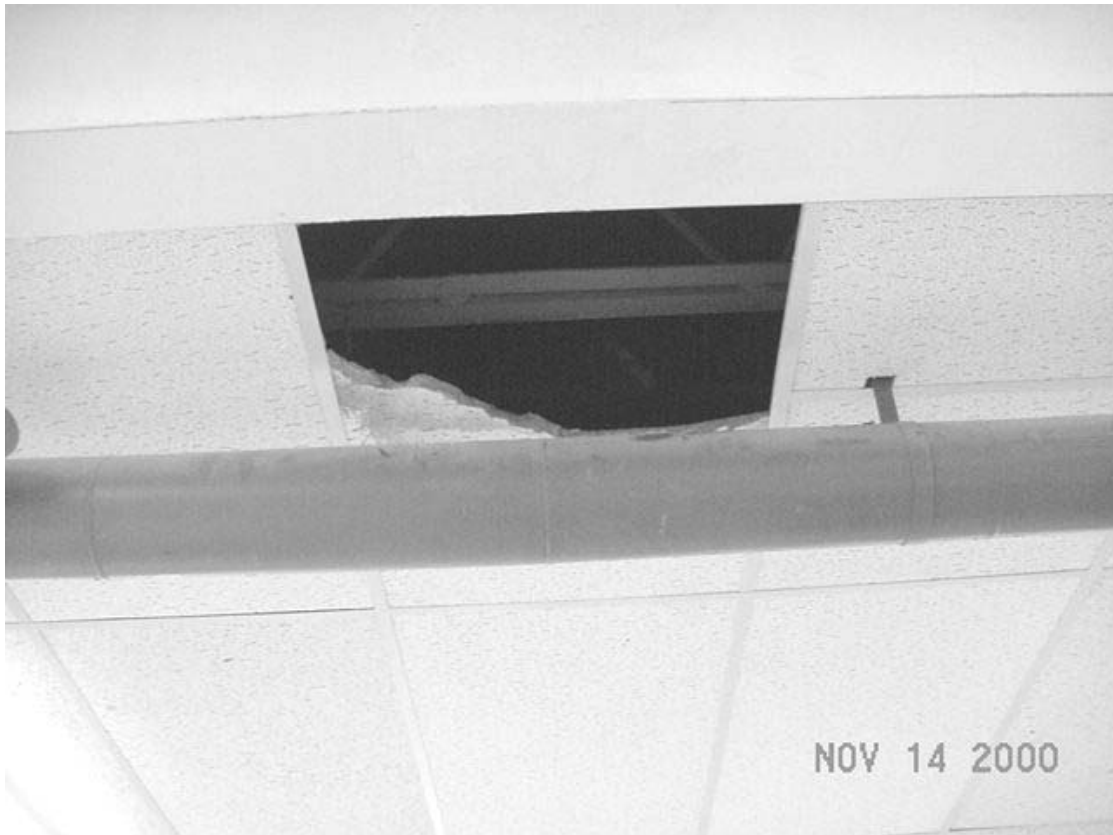
Picture 16

Several areas had open utility holes and/or missing/dislodged ceiling tiles (see Picture 16). Open utility holes can provide a means of egress for odors, fumes, dusts and vapors between rooms and floors. The missing/dislodged ceiling tiles can introduce dirt, dust and particulate matter into occupied areas of the school. These materials can be irritating to certain individuals.

Broken Ceiling Tile

Consideration should be given to installing a dedicated local exhaust vent for this area.
21. Prohibit smoking in this building in accordance with Massachusetts law M.G.L. Chapter 270, Sec. 22 (M.G.L., 1987).
22. Replace missing ceiling tiles and seal utility holes in ceilings and walls to prevent egress of odors, fumes and vapors.
23. It is highly recommended that the principles of integrated pest management (IPM) be used to rid this building of pests. As previously noted, a copy of the Massachusetts IPM recommendations is included with this report as Appendix A (MDFA, 1996).
24. Consider reconfiguring employee parking lot to avoid entrainment of vehicle exhaust. If this is not feasible, post signs in parking area instructing employees not to back in.
25. Consider installing a timer to activate the dark room exhaust system during school hours.

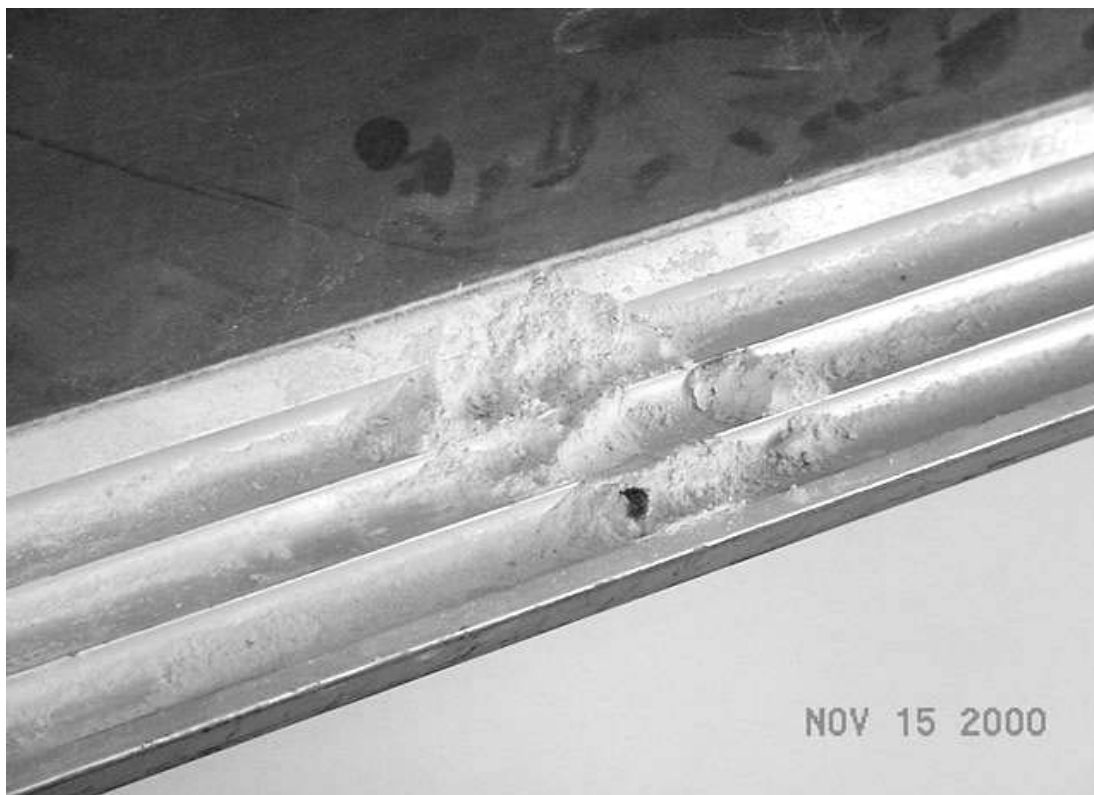
Picture 17

Accumulated chalk dust was noted in several classrooms (see Picture 17). Chalk dust is a fine particulate, which can be easily aerosolized and is an eye and respiratory irritant. Several classrooms contained dry erase boards and dry erase board markers. Materials such as dry erase markers and dry erase board cleaners may contain volatile

Accumulated Chalk Dust in Classroom

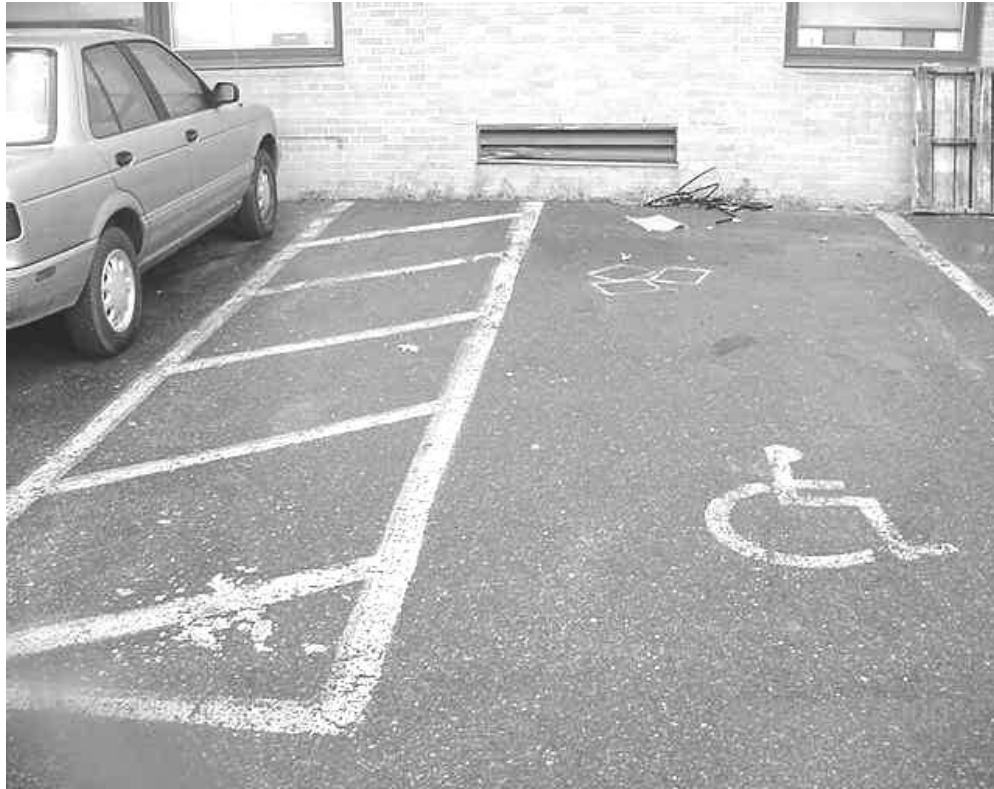
Although no complaints of vehicle exhaust emissions were reported, the possibility of entrainment exists. Picture 18 illustrates the close proximity of the employee parking lot to the building and the potential for vehicle exhaust entrainment by univent fresh air intakes. Idling vehicles can result in the entrainment of vehicle exhaust into the building. M.G.L. chapter 90 section 16A prohibits the unnecessary operation of the engine of a motor vehicle for a foreseeable time in excess of five minutes (MGL, 1996).

Proximity of Univent Fresh Air Intake to Employee Parking Lot
